# TESLA MODEL 3

From 2017 - 2021

TESLA-20173A-001

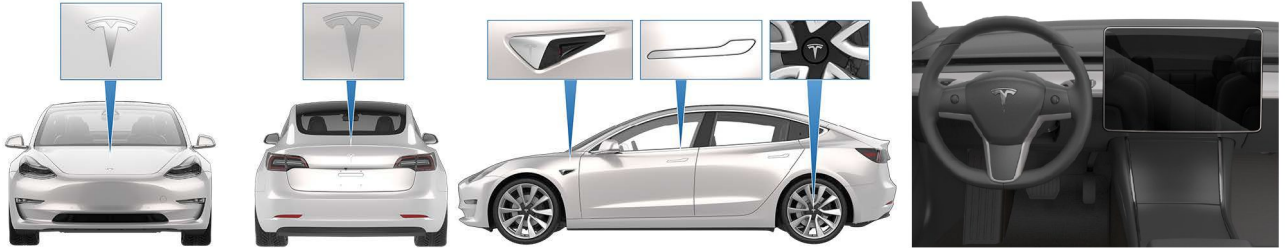
**NOTE:** The Tesla emblem indicates a fully electric vehicle.

**NOTE:** The model's name does not appear on the exterior of the vehicle.

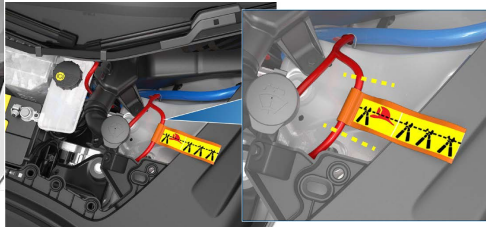
- Open the hood
- Double cut the First Responder Loop.
- Disconnect the 12V battery.

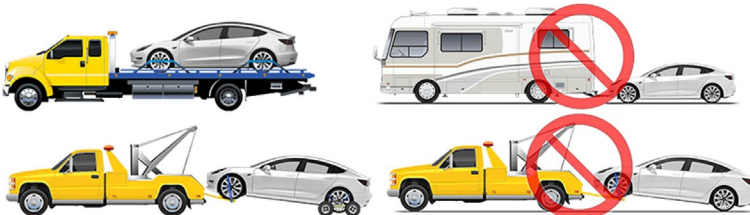
HV BATTERY TEMPERATURE SHOULD BE CHECKED BEFORE TRANSPORT
